# US Army ManTechJournal

## Corrosion Under Attack

Volume 10/Number 4/1985

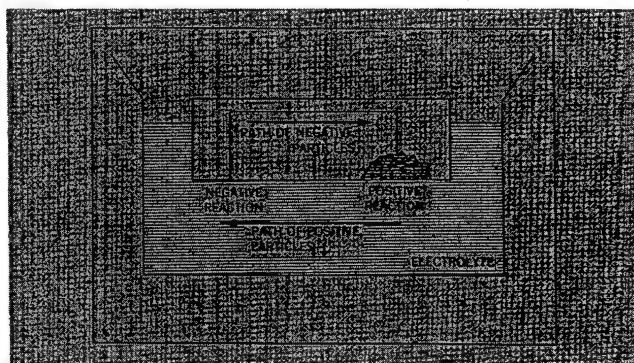
Figure 1

Rusting of iron and steel is caused by an electrochemical reaction. This reaction is divided into four parts or elements (Figure 1):

- A positive reaction
- A negative reaction
- A path for negative particles to flow
- A path for positive particles to flow.

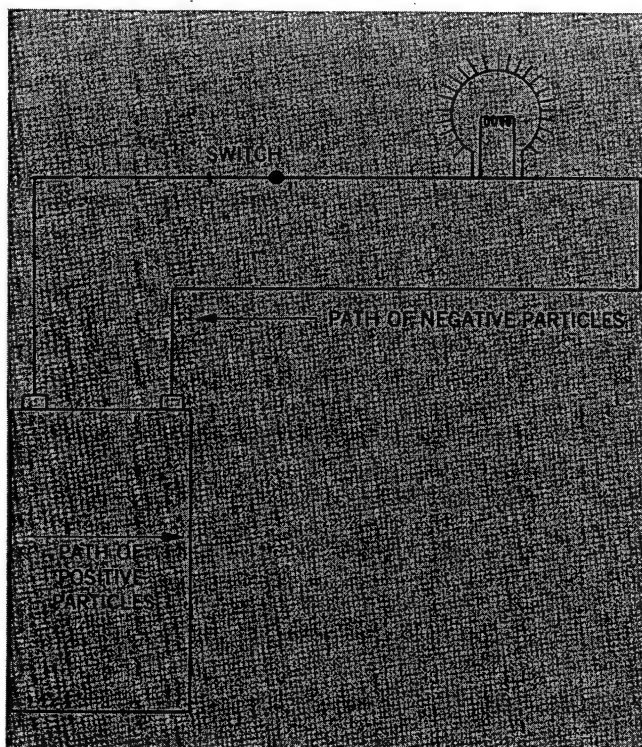
Figure 2

In the case of corrosion, positive and negative reactions take place either on two pieces of metal or on two

places of the same piece of metal. The negative particles either flow through the joint between the two metals or through the metal itself. The final, crucial element in the corrosion reaction is the path for the positive particles (the electrolyte). This electrolyte most often is water or salt water (Figure 3).

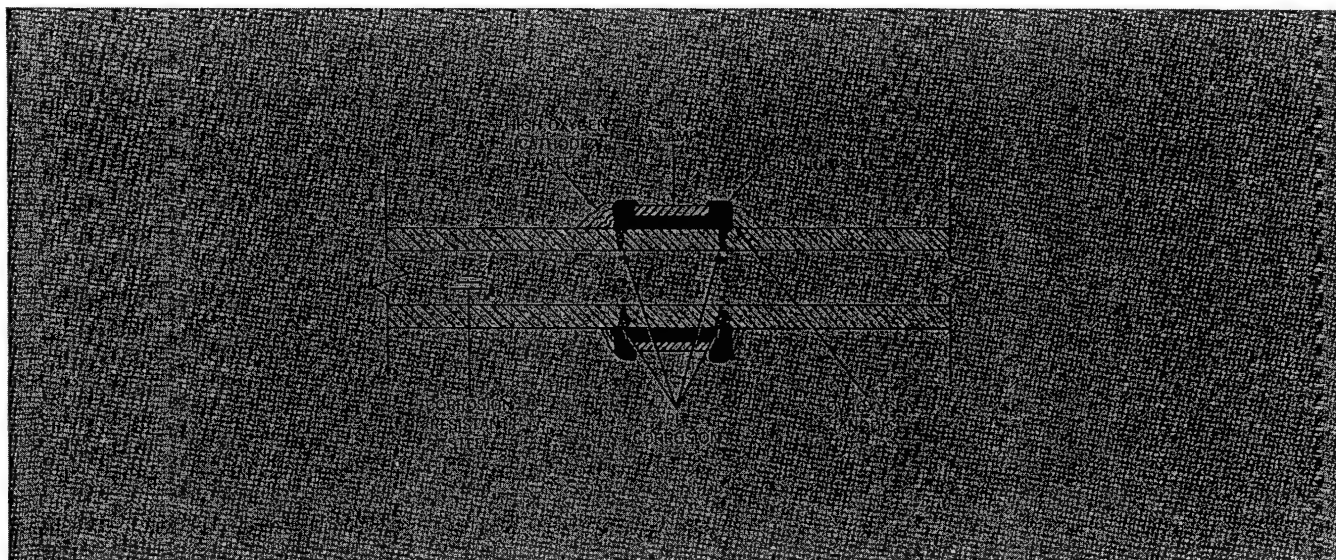
Figure 15 shows how these clamps can accelerate corrosion:

Corrosion is accelerated in areas where there is a differential in the amount of oxygen present. In Figure 15, it can be seen that the cushion seal results in a low oxygen area, while the line itself is in a high oxygen area. This differential, with water as an electrolyte, results in a rapid pit corrosion and line failure. Process these areas thoroughly.

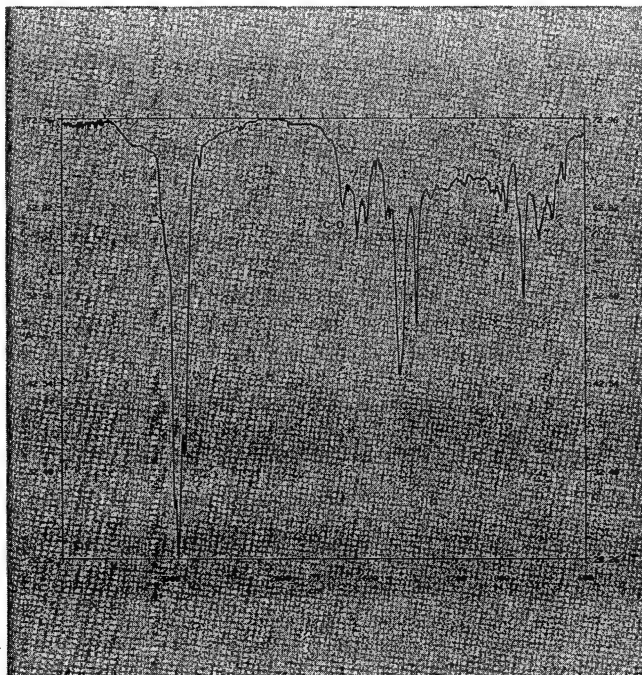
Figure 1. Infrared Spectrum of Methylene Chloride Extract of Relatively New Mask, Sample #1

Each residue was then redissolved in methylene chloride. A film was deposited on a potassium bromide salt crystal. An infrared spectrum was taken from 4000  $\text{cm}^{-1}$  to 600  $\text{cm}^{-1}$  (Figures 1-3).

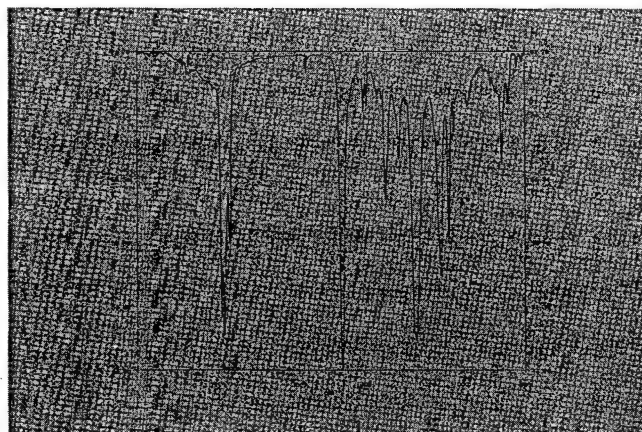
Figure 2. Infrared Spectrum of Methylene Chloride Extract of Gas Mask, Sample #2

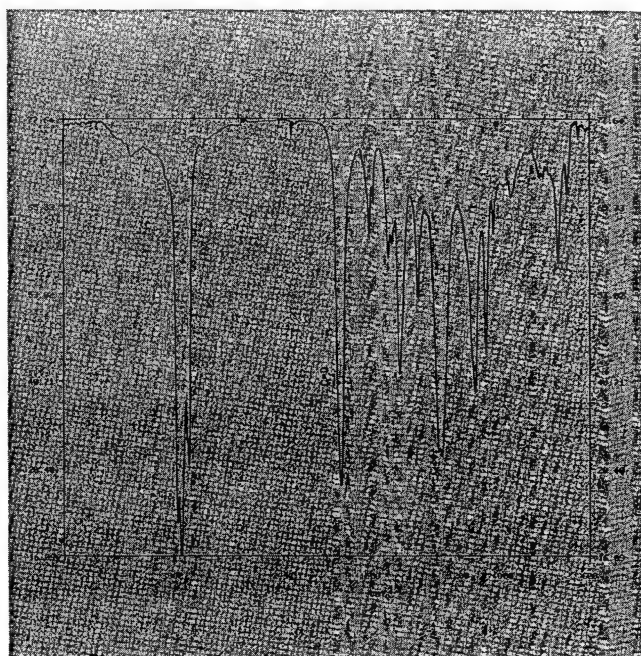
Figure 3. Infrared Spectrum of Methylene Chloride Extract of Dry Rot Throughout Entire Mask, Sample #3

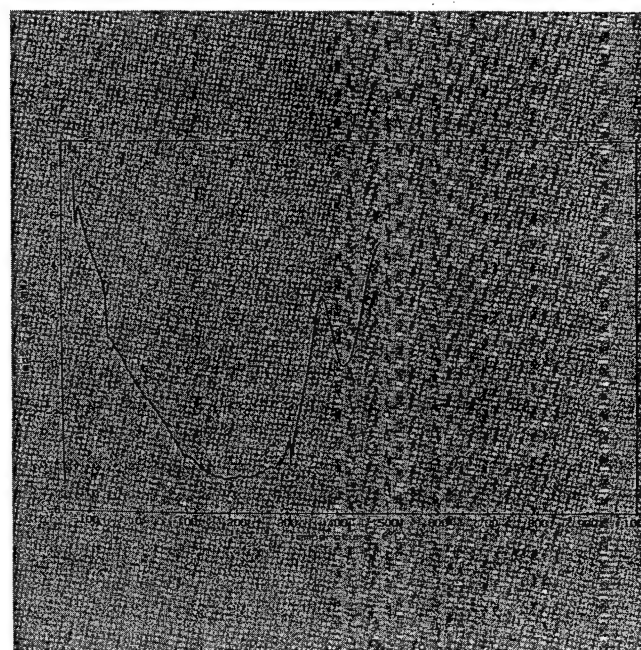
Figure 4. DSC Scan of Relatively New Mask, Sample #1

- **Differential Scanning Calorimetry Analysis (DSC), Thermogravimetric Analysis (TGA) and Thermo-mechanical Analysis (TMA).** The thermal analysis measurements were made on a Dupont 1090 thermal analyzer system utilizing a 910 DSC cell, a 951 thermogravimetric analyzer, and a 941 thermo-mechanical analyzer. Copies of the DSC scans are included with the experimental conditions listed on each scan (Figures 4-6).

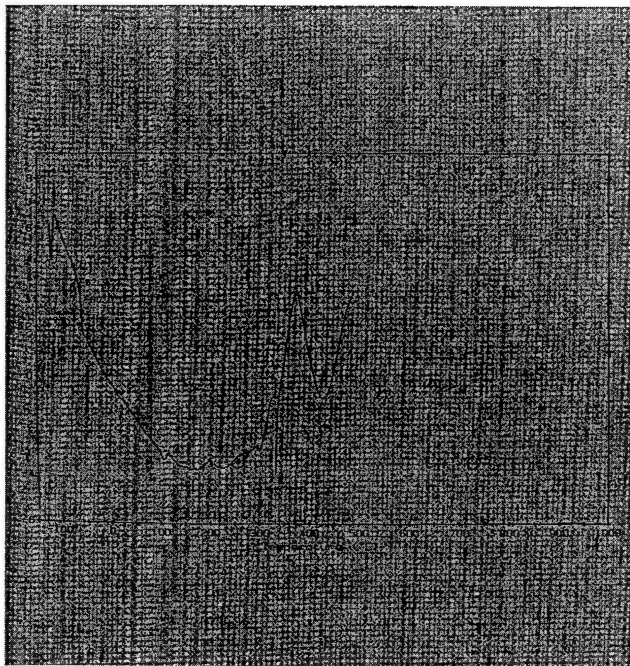
Figure 5. DSC Scan of Gas Mask, Sample #2

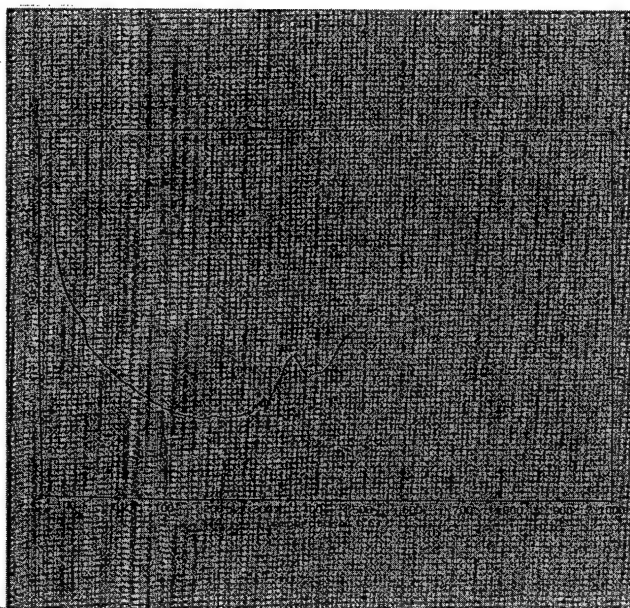
Figure 6. DSC Scan of Dry Rot Throughout Entire Mask, Sample #3

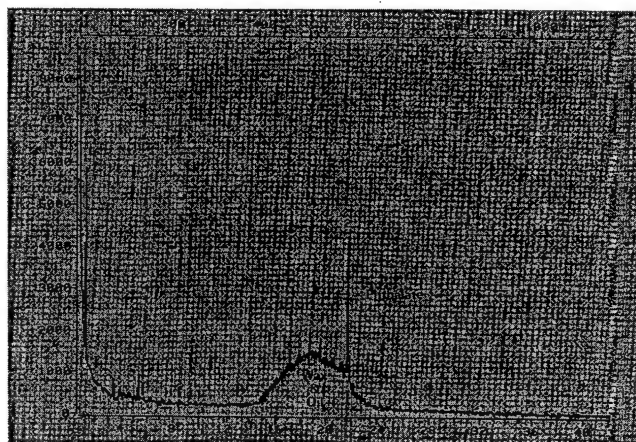
Figure 7. Gas Mass Chromatogram of Relatively New Mask, Sample #1

interfaced to a 1000 data systems. A 12 meter fused silica capillary column of cross-linked methyl silicone (SE-30) was programmed from 50 C to 260 C at 10 C/min. A mass range of 33-450 amu was repeatedly scanned at 2.5 second intervals. The chromatographic effluent was subjected to electron ionization spectrometry analysis at 70eV at  $5 \times 10^{-5}$  torr. Spectra derived from each analysis were compared to a computerized reference spectra contained in the Wiley-NBS data base. The pyrograms are shown in Figures 7-9.

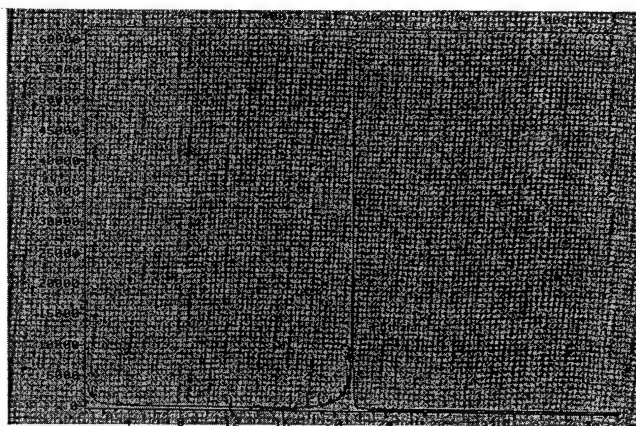
Figure 8. Gas Mass Chromatogram of Gas Mask, Sample #2

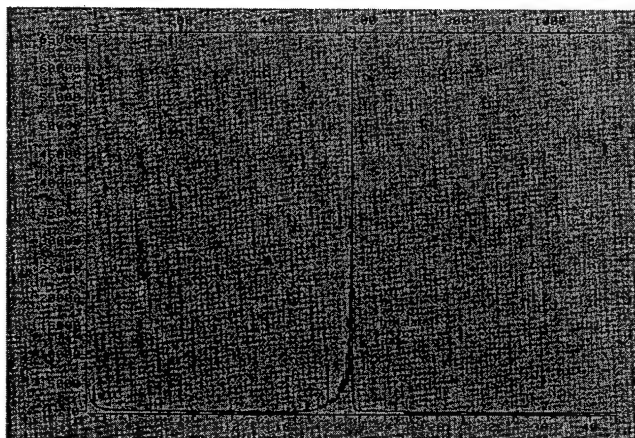
Figure 9. Gas Mass Chromatogram of Dry Rot Throughout Entire Mask, Sample #3

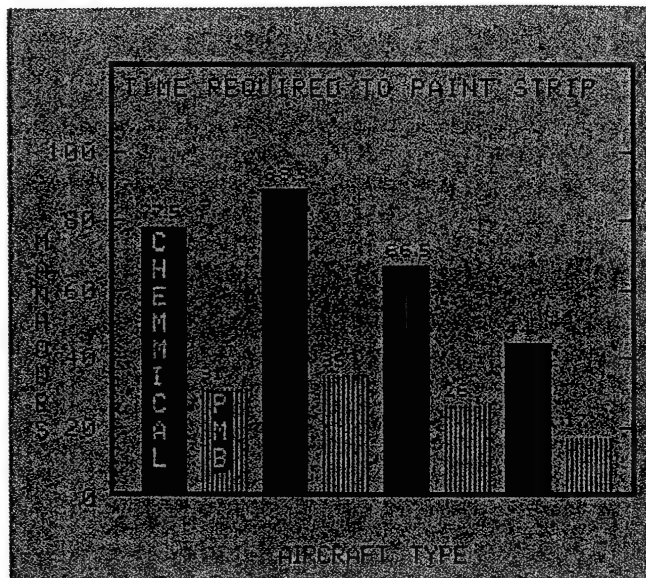
Figure 1 shows the relative times required to strip four different Army helicopters by Plastic Media Blast and by chemical means. Figure 2 shows the first rotary wing aircraft PMB stripped. The time required was 12 hours, compared to 32 hours by chemical strip. The effectiveness of PMB on fiberglass airframe components is seen in Figure 3, a closeup of the nose of the helicopter.

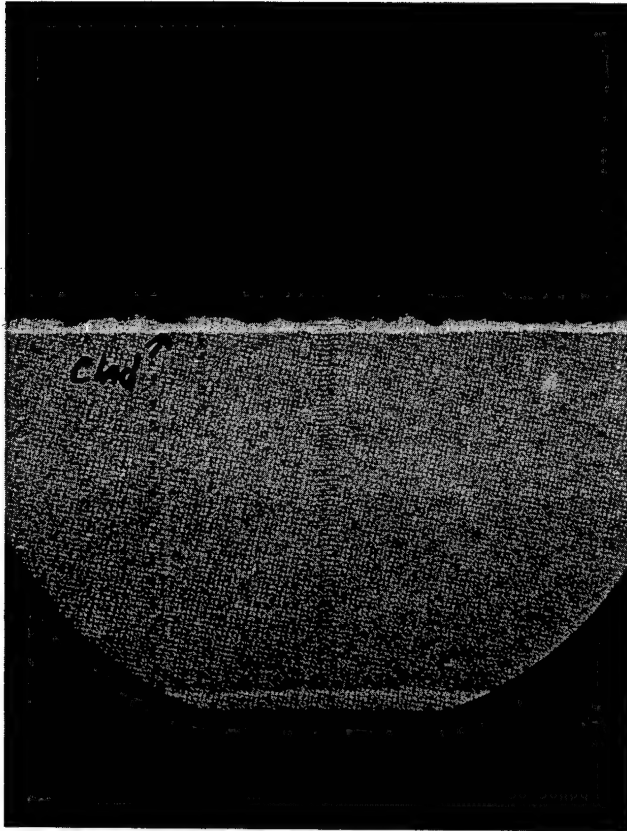
Figures 4, 5, and 6 illustrate how the lack of damage to aircraft surfaces can extend the life of that aircraft. Figure 4 shows a helicopter tailboom which was primed, painted, and Plastic Media Blasted five times. Figure 5 is a closeup of the skin section of this tailboom. The darkened, smudged areas are residual primer still attached to the skin. It is not necessary to remove all of the primer down to white metal if MIL-P-23377 epoxy primer is used. Figure 6 is a photomicrograph of a skin section from this tailboom. The average clad thickness of the

blasted side is 0.0015 inch, compared to a thickness of 0.0022 inch for the unblasted side. With five years between strip and paint cycles, this photomicrograph represents a life span of 25 years on the skin.

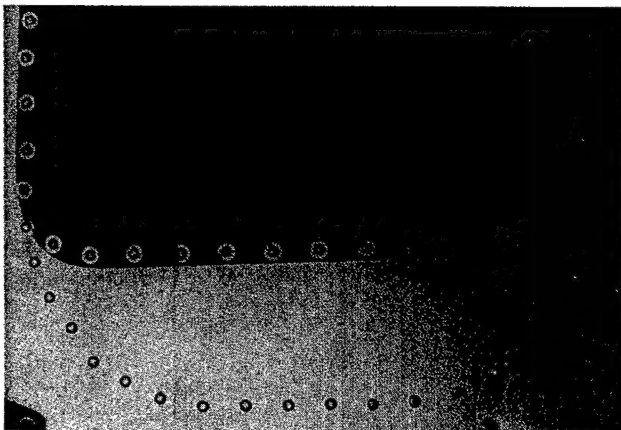
Figure 11

Another special benefit from PBM is seen in Figure 11, which illustrates how effective the technique is for removing finishes from rivets and screws without damaging the skin surfaces or the fasteners themselves and the joint itself.

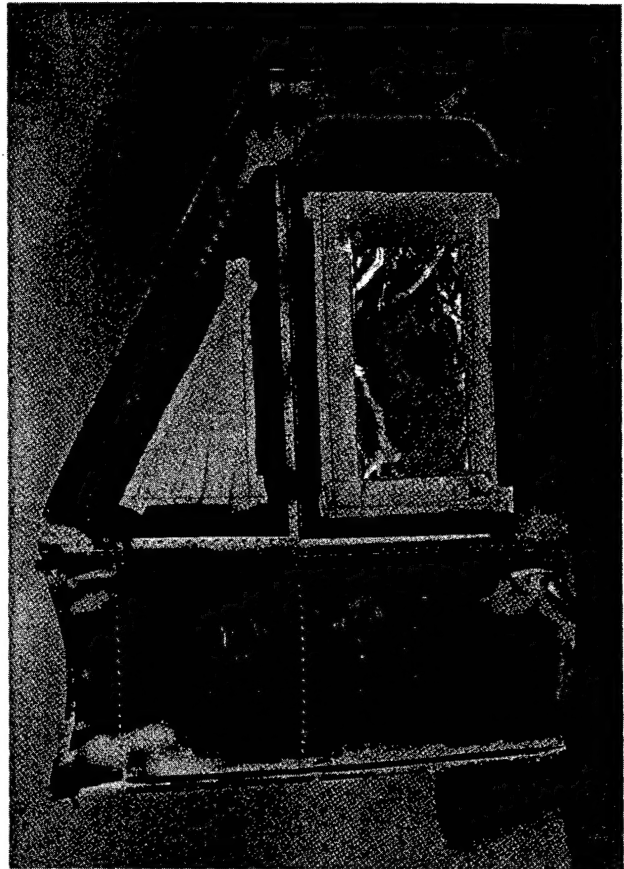
Figure 12 illustrates another unique advantage of using Plastic Media Blast stripping. It shows a helicopter door after selective stripping using low pressure and small media, with only the top coat of paint removed.
